Machinery Messages

Protection against thrust bearing failure in a steam turbine

by Charlie Jackson
Turbomachinery Consultant

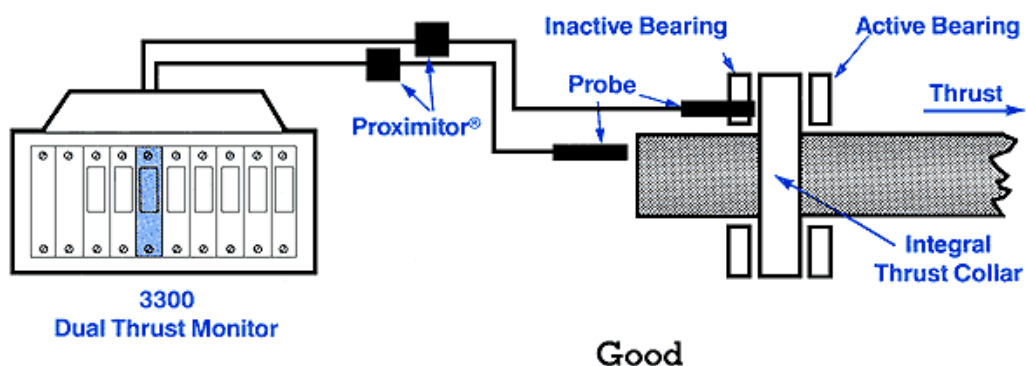
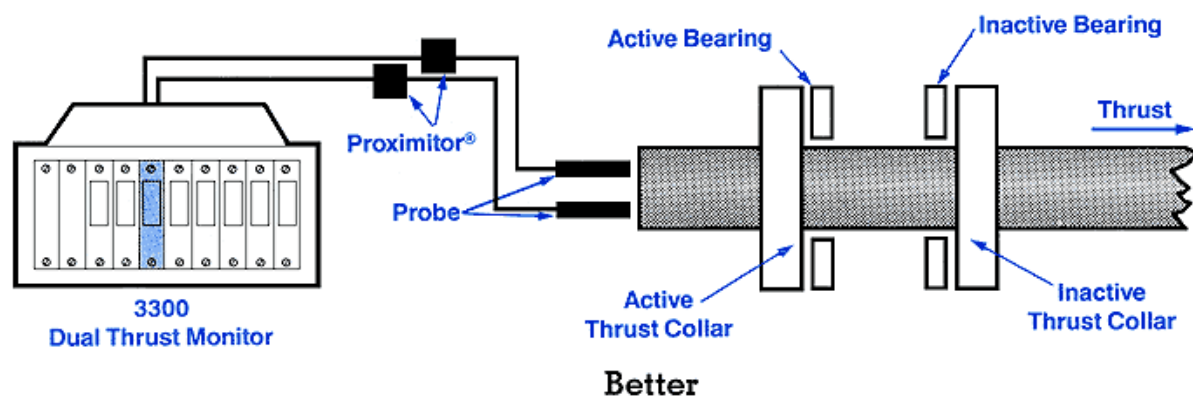
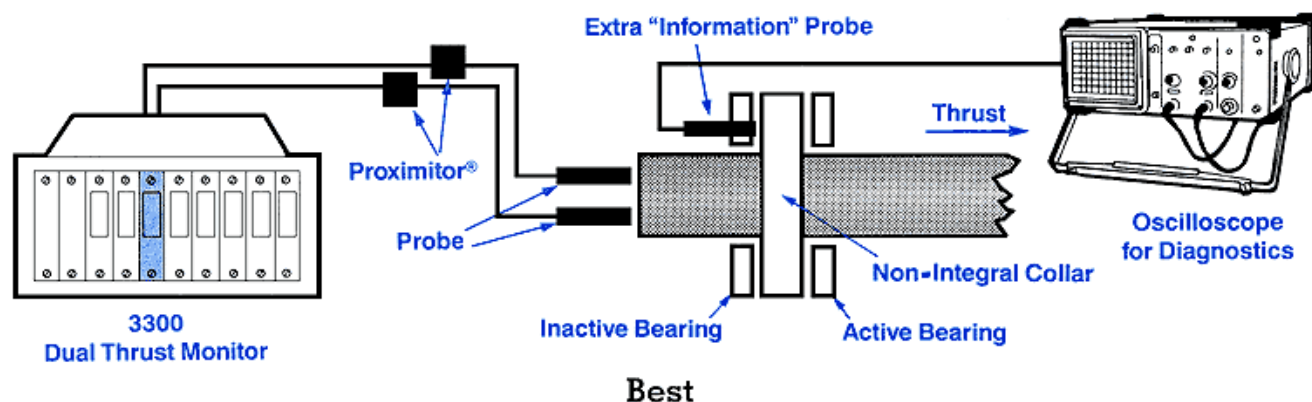
Figure 1
Thrust (Axial) probe arrangements

The best protection is an instrumentation system which is dedicated towards axial deflection detection, with dual-voting eddy current proximity sensors mounted in the turbine's steam inlet section as is shown in Figure 1. Generally, sensors are mounted in the steam end pedestal end plate. These two displacement probes, calibrated to the dc gap voltage, indicate the distance from the sensor tips to the end of the turbine shaft. The end of the turbine shaft must be in close proximity to the

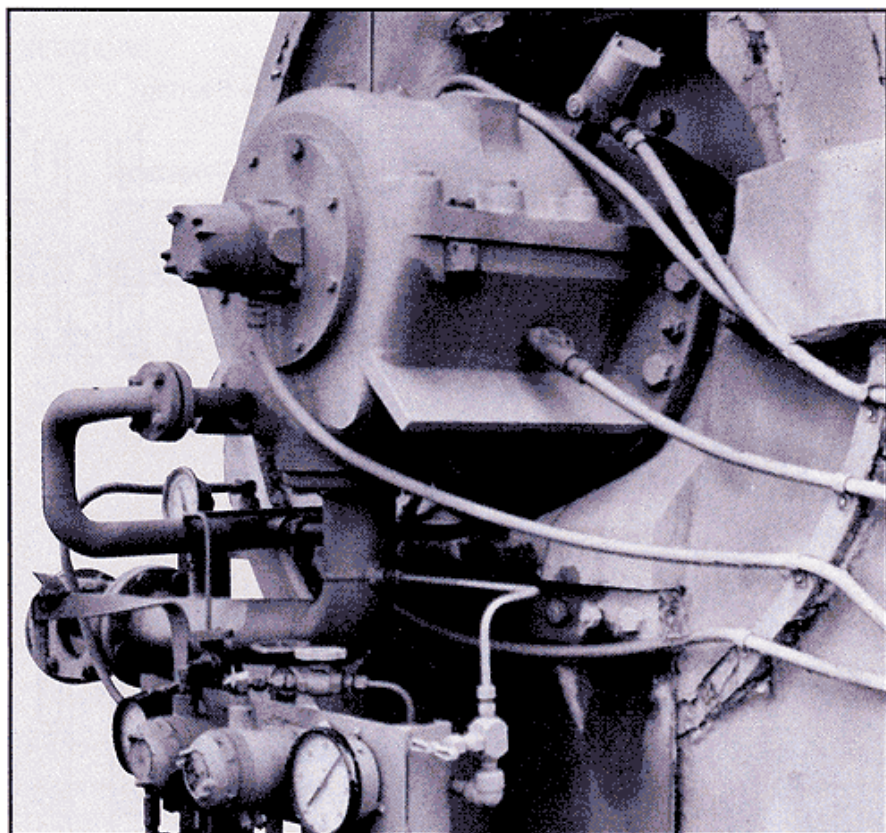
Figure 2
Dual thrust proximity probe machine protection assembly on a centrifugal compressor's discharge end bearing assembly.

Figure 2 shows a dual thrust protection assembly on a centrifugal compressor's discharge end bearing assembly. The radial vibration probes can be seen mounted in the standard API 670 XY configuration. The compressor incorporates a balancing piston

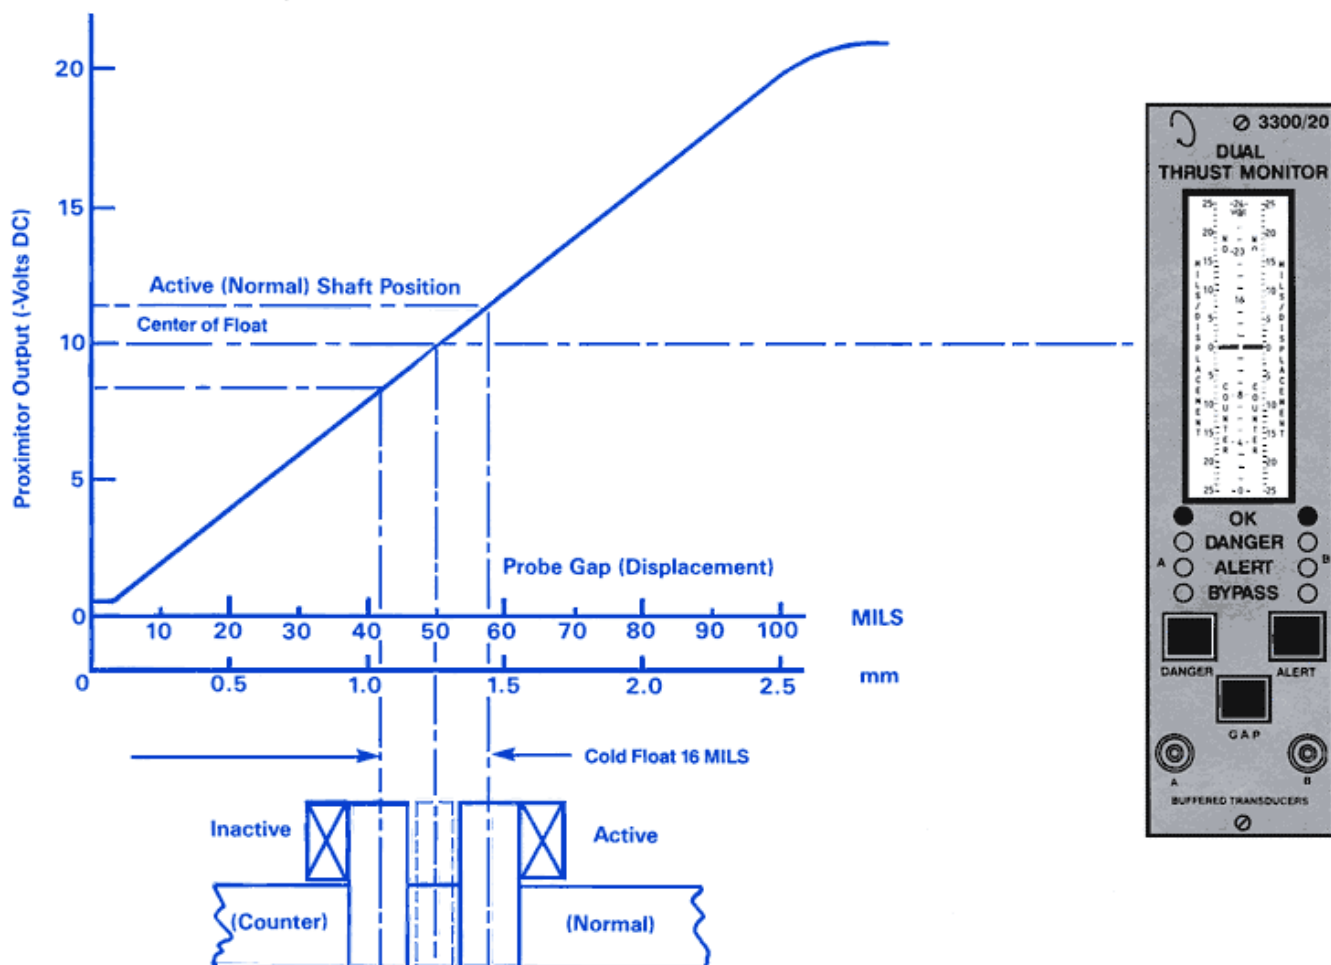
Figure 4

At 25 mils (636 μm), these machines will shut down automatically. The "cold float" on the turbines is 16 mils (406 μm). The cold float on the compressors is 17 mils (432 μm), i.e., active to inactive "bump" check. The cold float zone (Figure 4) is measured when the machine is at rest and cold (ambient

Center zero equals thrust collar in center of cold float zone as is shown on 3300/20 front panel display.
